# Manhole Inspection Summary

Manhole # S33WW1012MH

Insp Date: **1/29/07 10:47 AM**

**Location** Address: **206 ENFIELD RD**

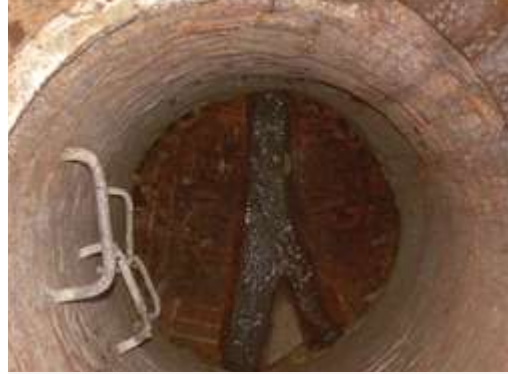
Top View

Evidence of surcharge - Bench debris.

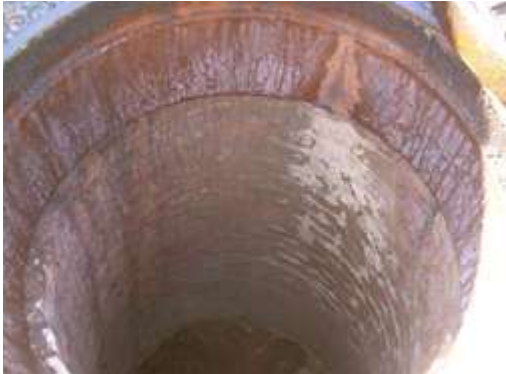
Defect

Frame leaks. Frame offset. Adjustment deterioration and infiltration. Barrel infiltration - other side.

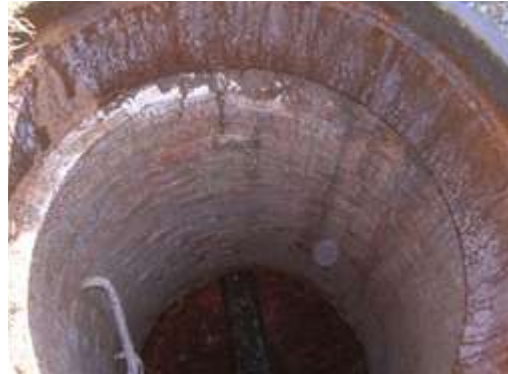
Defect

Frame leaks. Frame offset. Adjustment deterioration and infiltration.

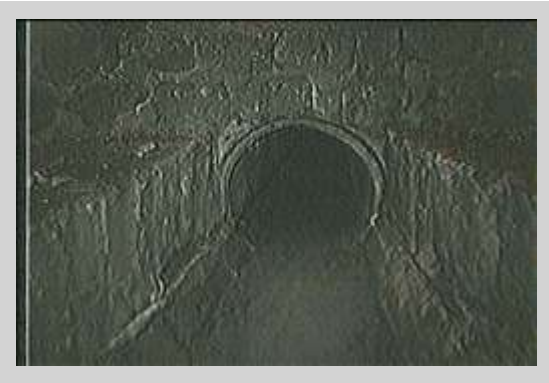
### 8 in. Circular Gravity Sewer Pipe Out @ 12 O'Clock

Barrel deterioration and infiltration. Channel deterioration.

Infiltration: **Evidence** Pipe Seal Cond: **Cracked**

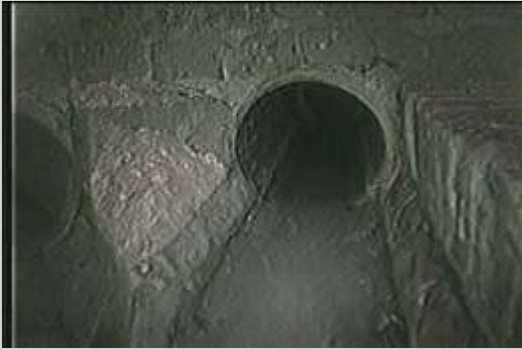
Pipe In @ 6 O'Clock

Channel deterioration.
